Drawing register and general notes

27 FRANK STREET, WETHERILL PARK NSW

CEDR-27FS-DRW-003 | TEMPLATE CEDR-A3-03 v6 | 14 OCT 2026

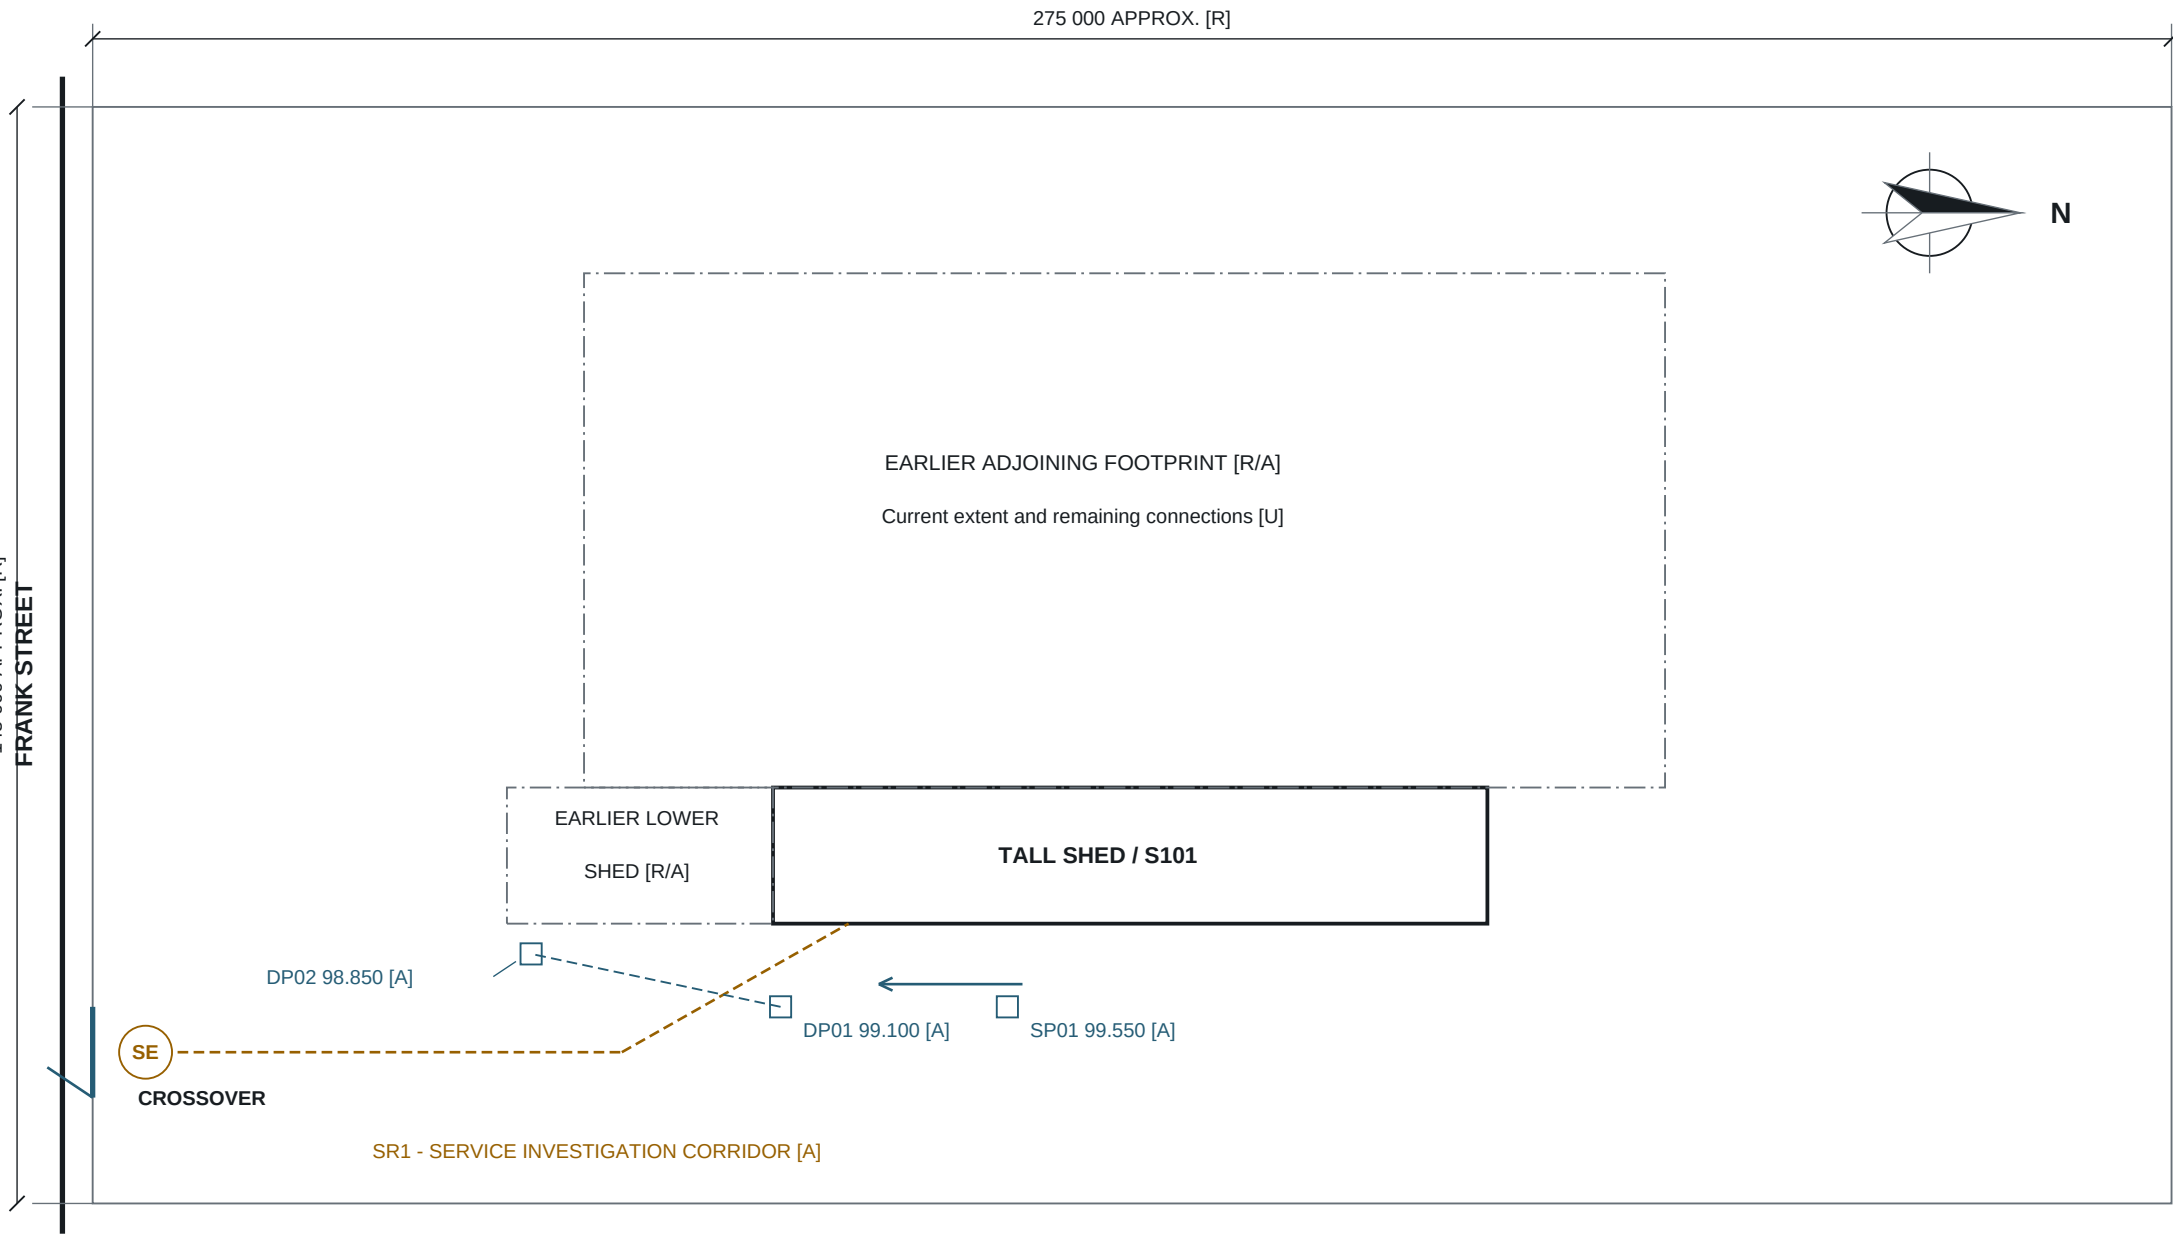
Site, services and drainage

SE: reported electricity and telco entry near the driveway crossover. Precise locations and service ownership [U].

SR1 is an assumed investigation corridor, not a located service.

Locate all services; obtain isolation/protection evidence before structural work. Overhead line voltage, alignment and clearances [U].

P08 shows a grated inlet. Its identity and levels have not been matched to DP01/DP02.

Assumed local levels provide a relative surface fall. Pipe invert, gradient, size, capacity and outfall are not established. Drainage features require survey and identification.

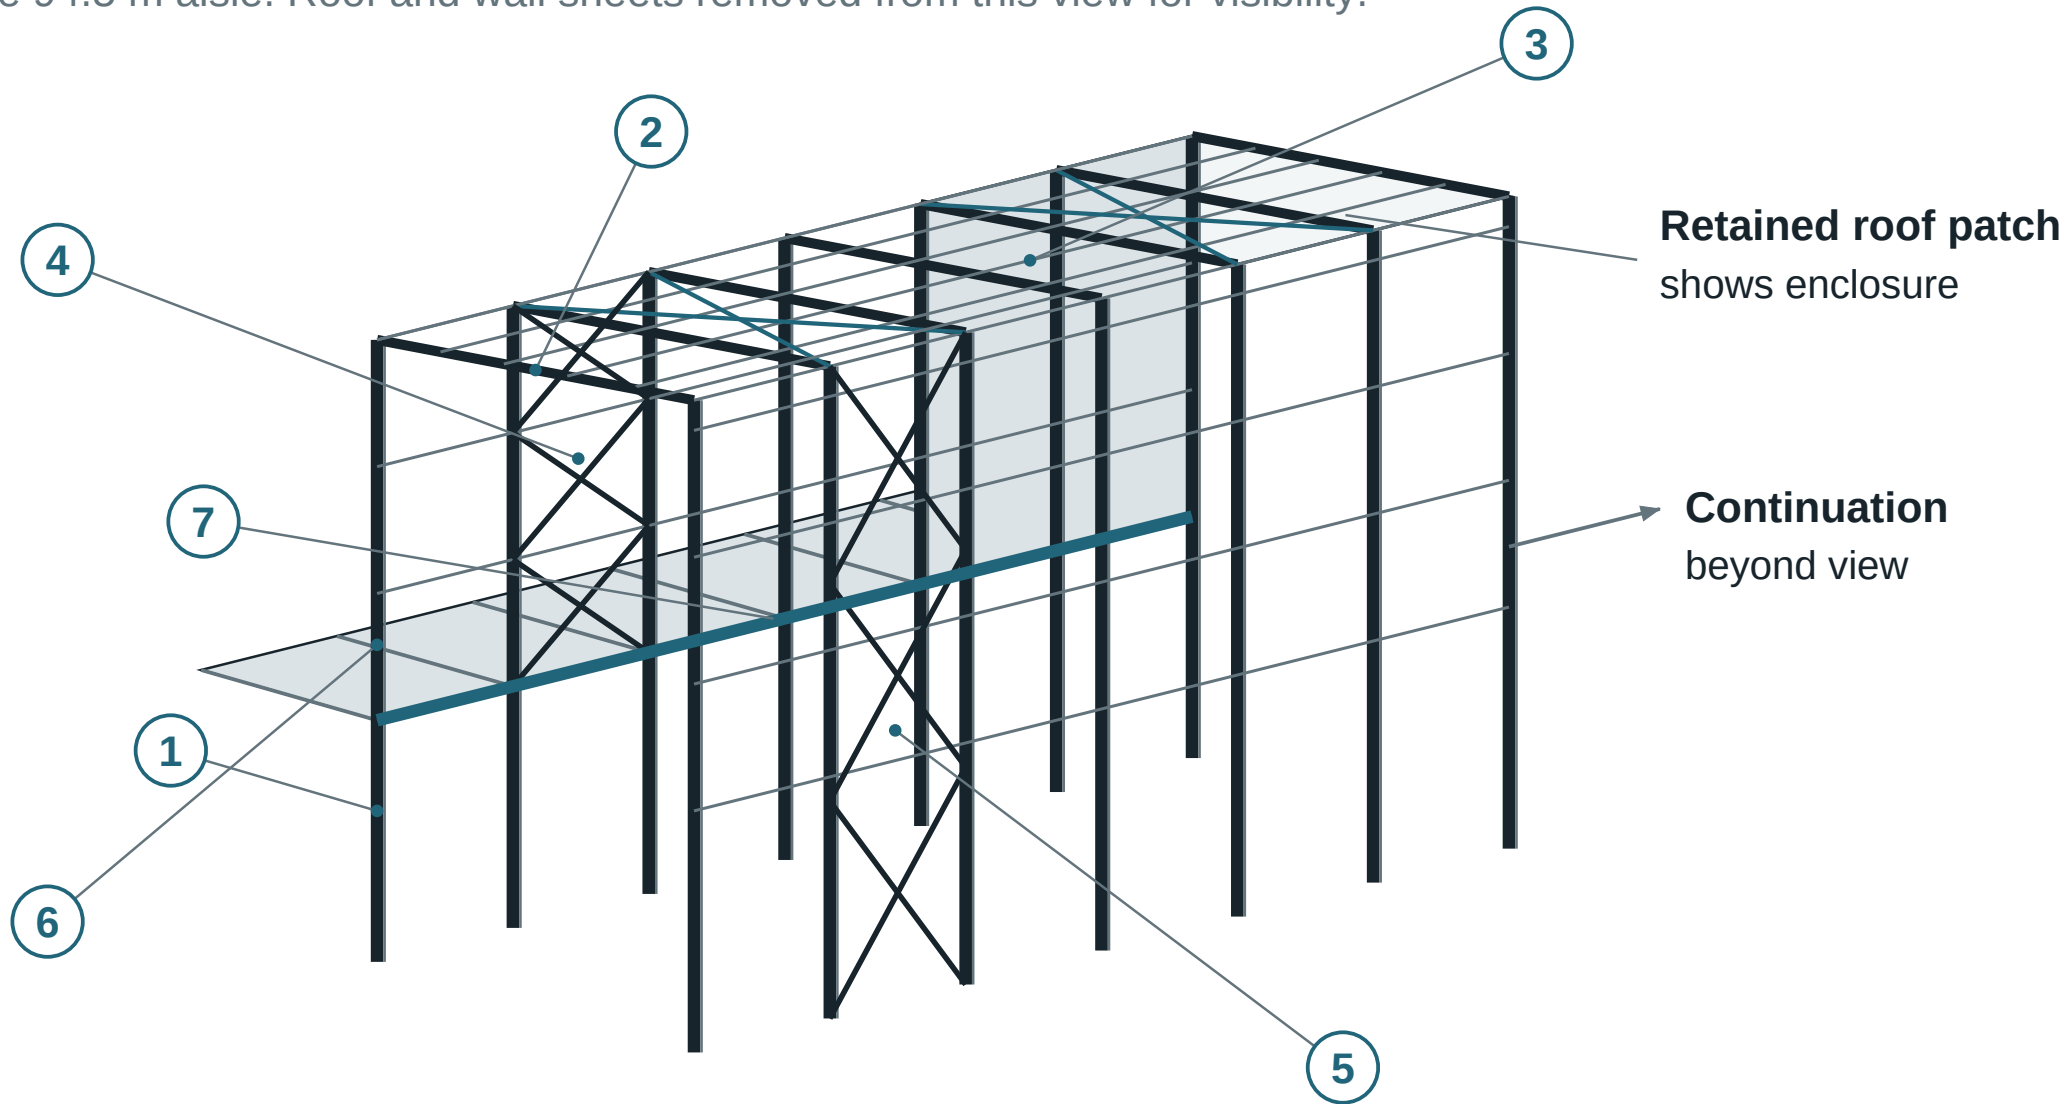
SIX-BAY INSPECTION CUTAWAY

Part of the 94.5 m aisle. Roof and wall sheets removed from this view for visibility.

- 1 Column 2 Rafter 3 Purlin 4 Upper brace tiers 5 Full-height brace tiers  
6 Adjoining lower roof 7 Interface beam. Bay locations and levels schematic; compare I12-04 / S103.

Follow primary frames, secondary members and stacked brace panels. IF1 marks continuous framing at the tall/lower-roof junction; LR1 marks the adjoining lower roof. Source relationships are enlarged on S103.

First-inspection cutaway: most roof and wall sheets are omitted to expose members. Grid and tier allocation are schematic. Compare the earlier enclosed condition with later P01-P09; use S302 for observed brace nodes.

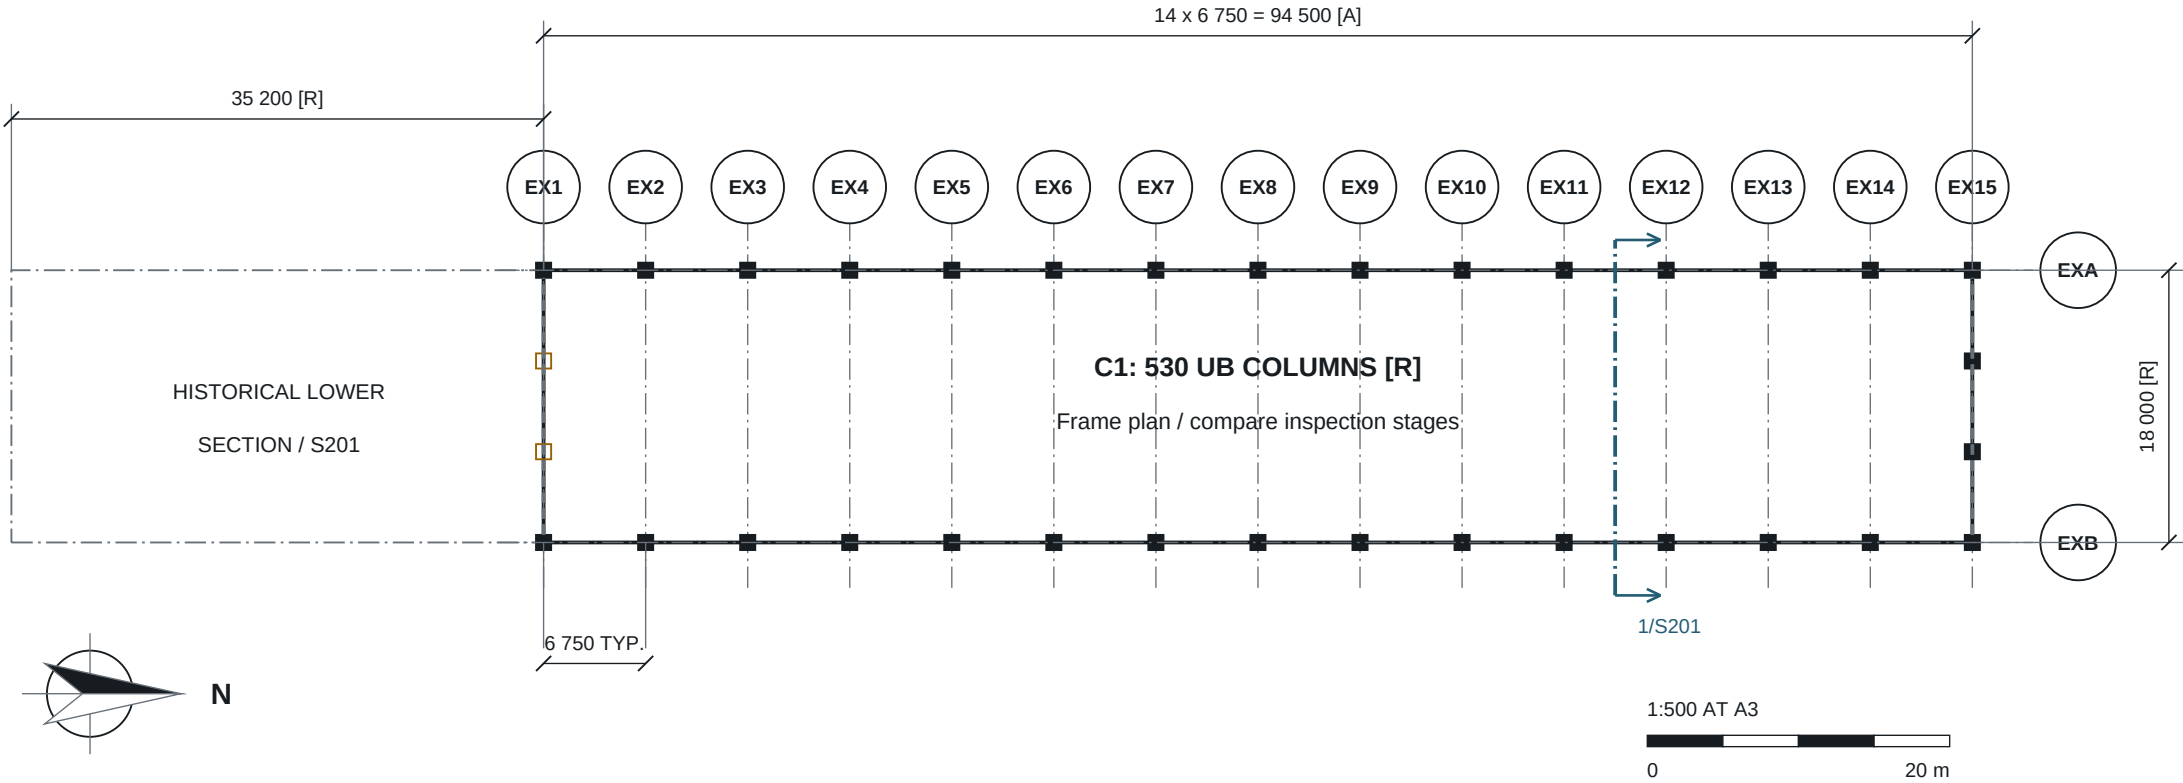
Existing structure - column layout

The source bay chain totals 94 345. This layout regularises it to 14 x 6 750 = 94 500, a 155 difference [A]. Survey controls final dimensions.

Source northern infill posts: two at 6 000 centres. Southern infill posts assumed at matching centres.

IF1 continuous interface framing is photo-observed on the tall/lower-roof side. MB1 denotes separate deep end members in later photos. Do not treat them as one member. See S103/S201.

C1 main columns: 530 UB [R]; full designation, grade and capacity [U]. EP1 end posts; north arrangement [R], south arrangement [A]. MB1 is indicated overhead by a dashed line; it is not a wall.

Concealed footing connections and roof haunch details are unverified. The earlier lower roof meets the tall frame through IF1 and associated connections. Review each tie and the change between stages; see S103.

Plan north is to the right. EXA = west; EXB = east. All grid allocations are to be checked against site survey.

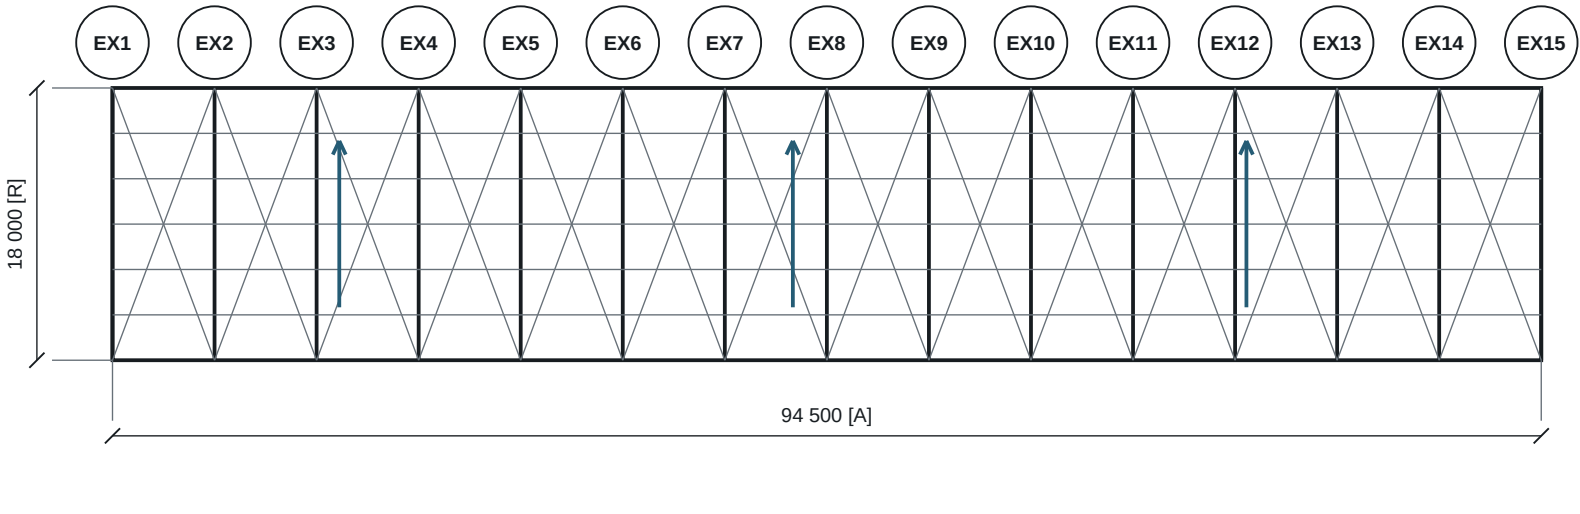
ROOF PLAN

Roof sheets retained in the photographic record. R1 roof members, P1 purlins, RB1 bracing.

Source: roof horizontal bracing all spans. Positions and sections require verification. Arrow indicates fall from EXB to EXA.

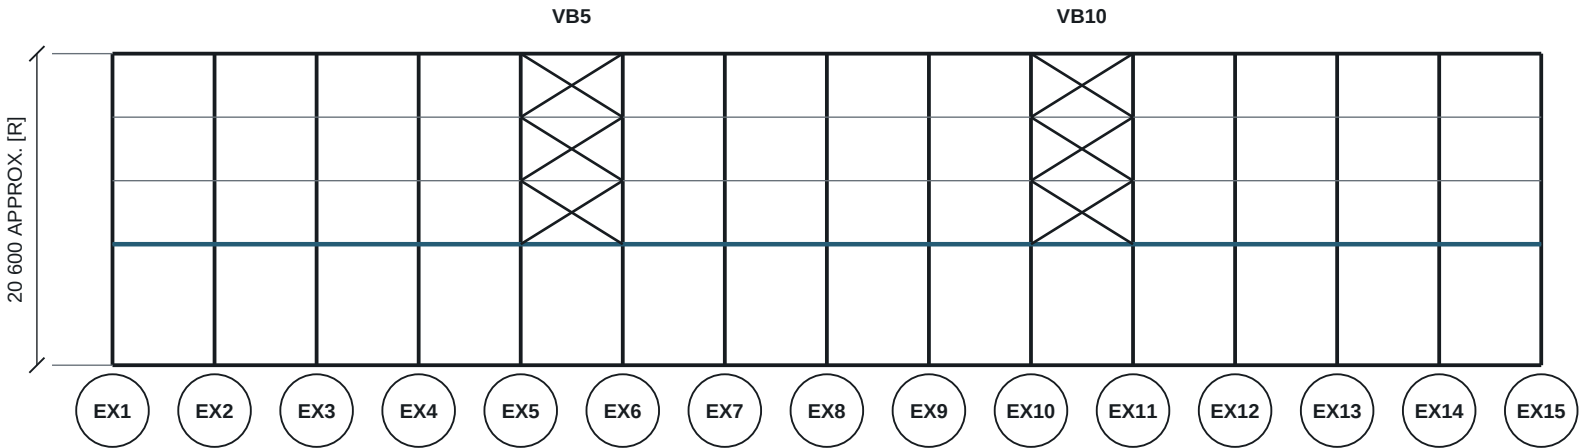
INTERFACE ELEVATION / EXA ASSIGNMENT [A] - 1:500

Source: bracing every fifth span. Bay allocation and panel levels here are schematic [A]. Photos show stacked upper panels terminating at IF1; see S103.

IF1 blue line represents the adjoining roof interface. Do not infer that each upper brace continues to a footing. Full-height wall bracing differs; V002.

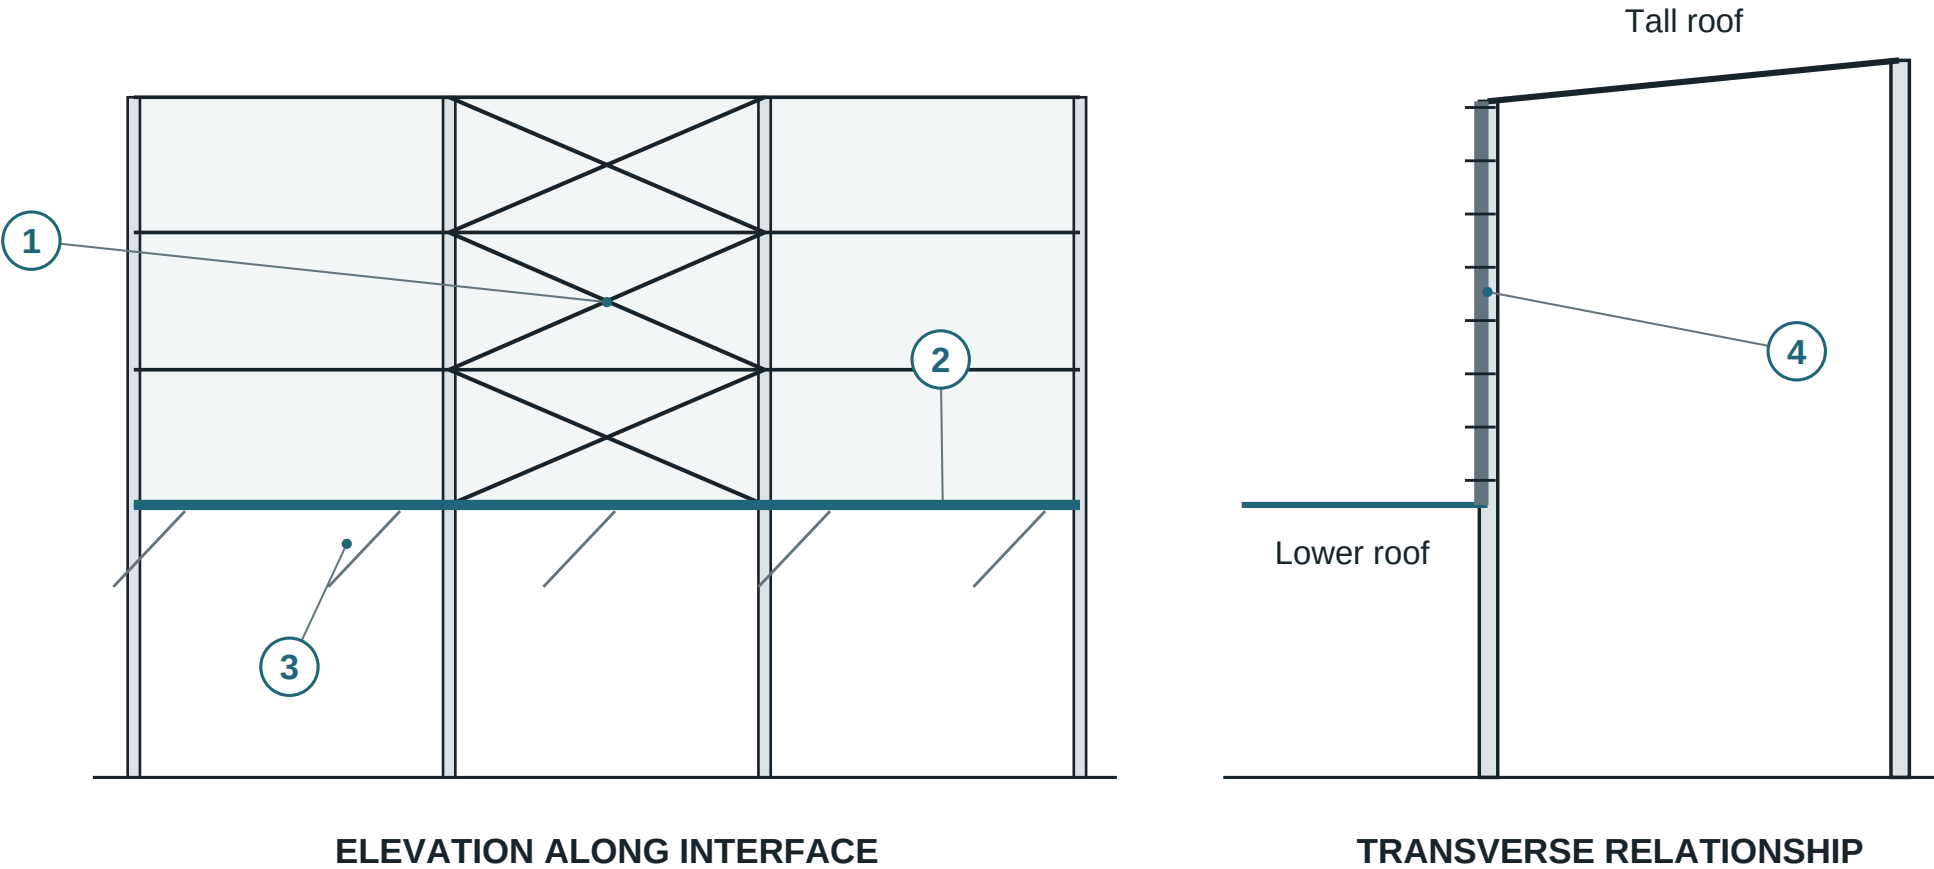
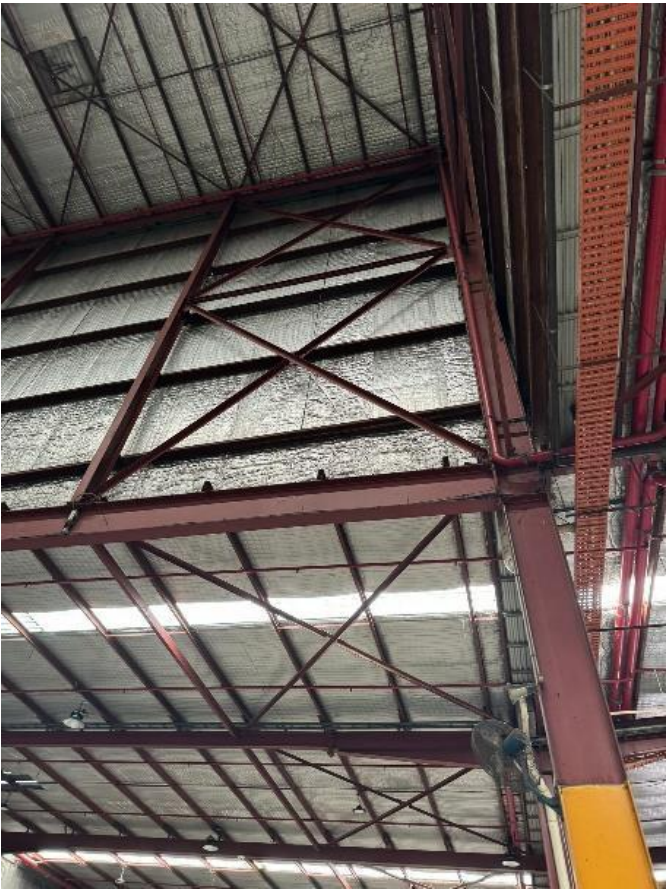
TALL / LOWER ROOF INTERFACE - FIRST INSPECTION

Observed relationships from I12-04 and I13-01. Partial elevations and section, NTS.

I12-04 | source p.12 middle-right  
Upper braced wall above lower roof; horizontal interface framing and attached service routes.

1 Stacked upper braces 2 Continuous interface framing 3 Lower roof framing 4 Upper wall band  
Grid match, member roles and exact levels require correlation. The lower roof is not a mezzanine floor.

First-inspection reconstruction: schematic relationships, not a measured wall or opening set-out. Later condition: V001.

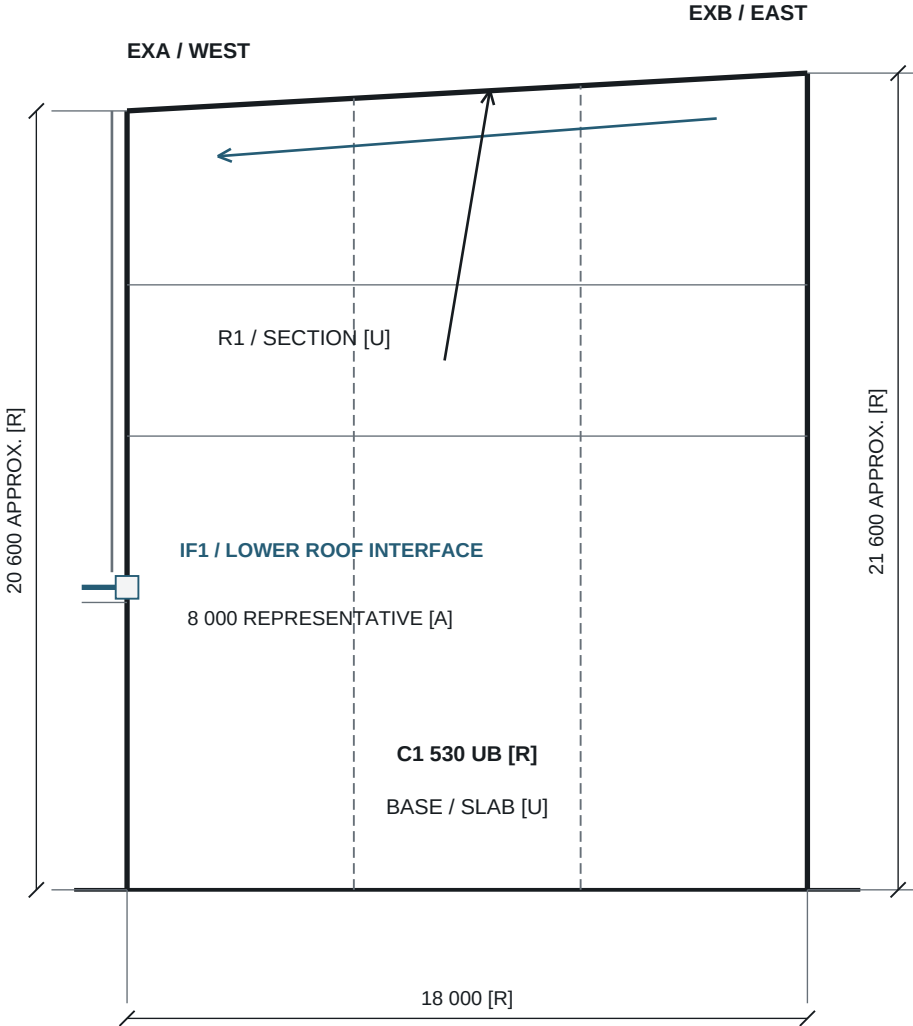
1 / S201 TALL SHED SECTION

Tall heights are approximate source ceiling-height references, not surveyed roof-top levels. Dashed verticals show two end infill posts; they do not occur at every transverse frame. Northern posts at 6 000 centres are source-based; southern placement is assumed.

IF1 is continuous framing at the adjoining lower-roof junction, visible in first-inspection photos. The 8 000 level and west-side allocation here are representative [A]. Separate deep end members MB1 appear in later photos; they are not depicted across every transverse frame. Their level, role and extent need reconciliation.

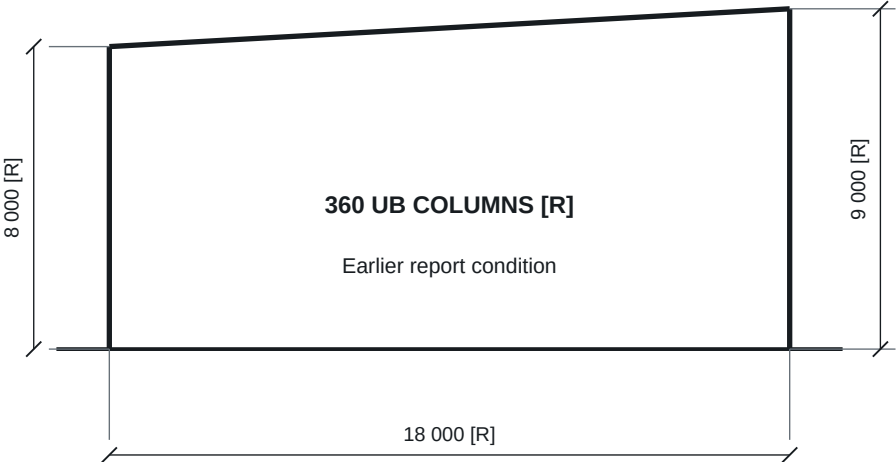
2 / S201 HISTORICAL LOWER SHED

Floor datum 100.000 LOCAL is assumed. Historical lower shed is context, not a confirmed retained structure. Verify the actual interface and temporary stability before separating connected members.

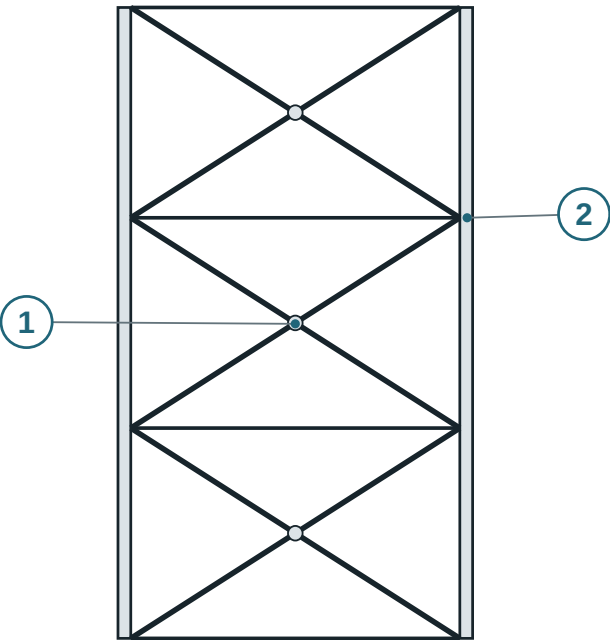
STACKED BRACED PANELS

Panel subdivisions and opening positions below are explanatory, not measured elevations.

1 Brace crossing 2 Column node 3 Opening header 4 Low solid wall zone 5 Attached service route

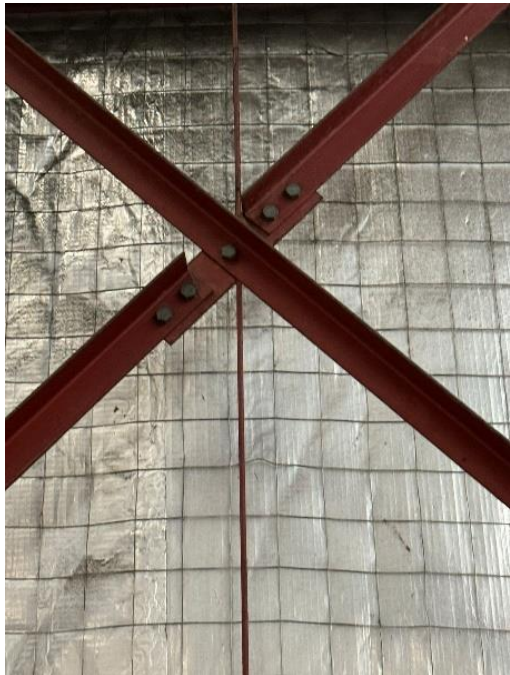
BRACE CROSSING

I10-01 | Original report p.10 top-left

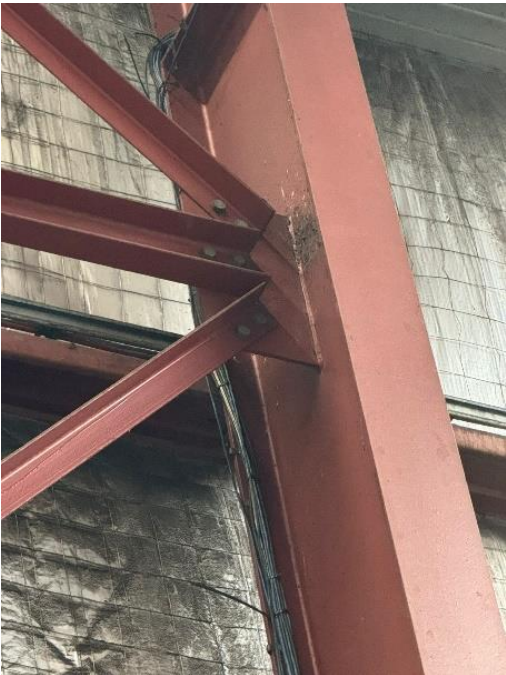
COLUMN NODE

I10-02 | Original report p.10 top-right

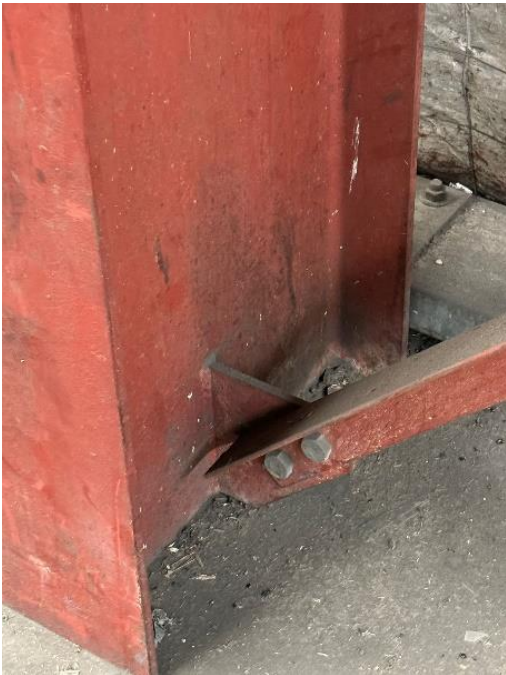
LOW BRACE CONNECTION

I10-03 | Original report p.10 middle-left

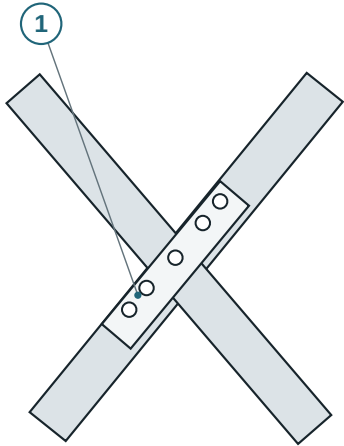
X-BRACE CROSSING

Photo-linked line studies. No bolt, plate, weld or capacity schedule is inferred.

I10-01 / source p.10 top-left

Read the source photographs with these studies: member overlap, bolt groups, plates and column contact.  
The visible brace connection does not establish concealed footing anchorage. Refer S302 for the source images.

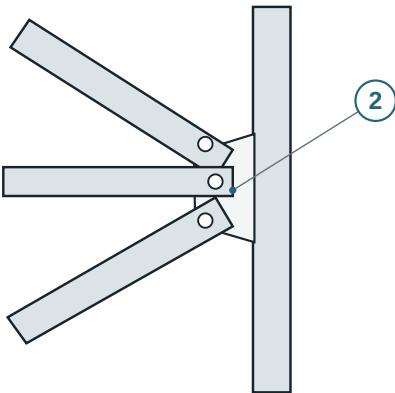
MULTI-MEMBER COLUMN NODE

I10-02 / source p.10 top-right

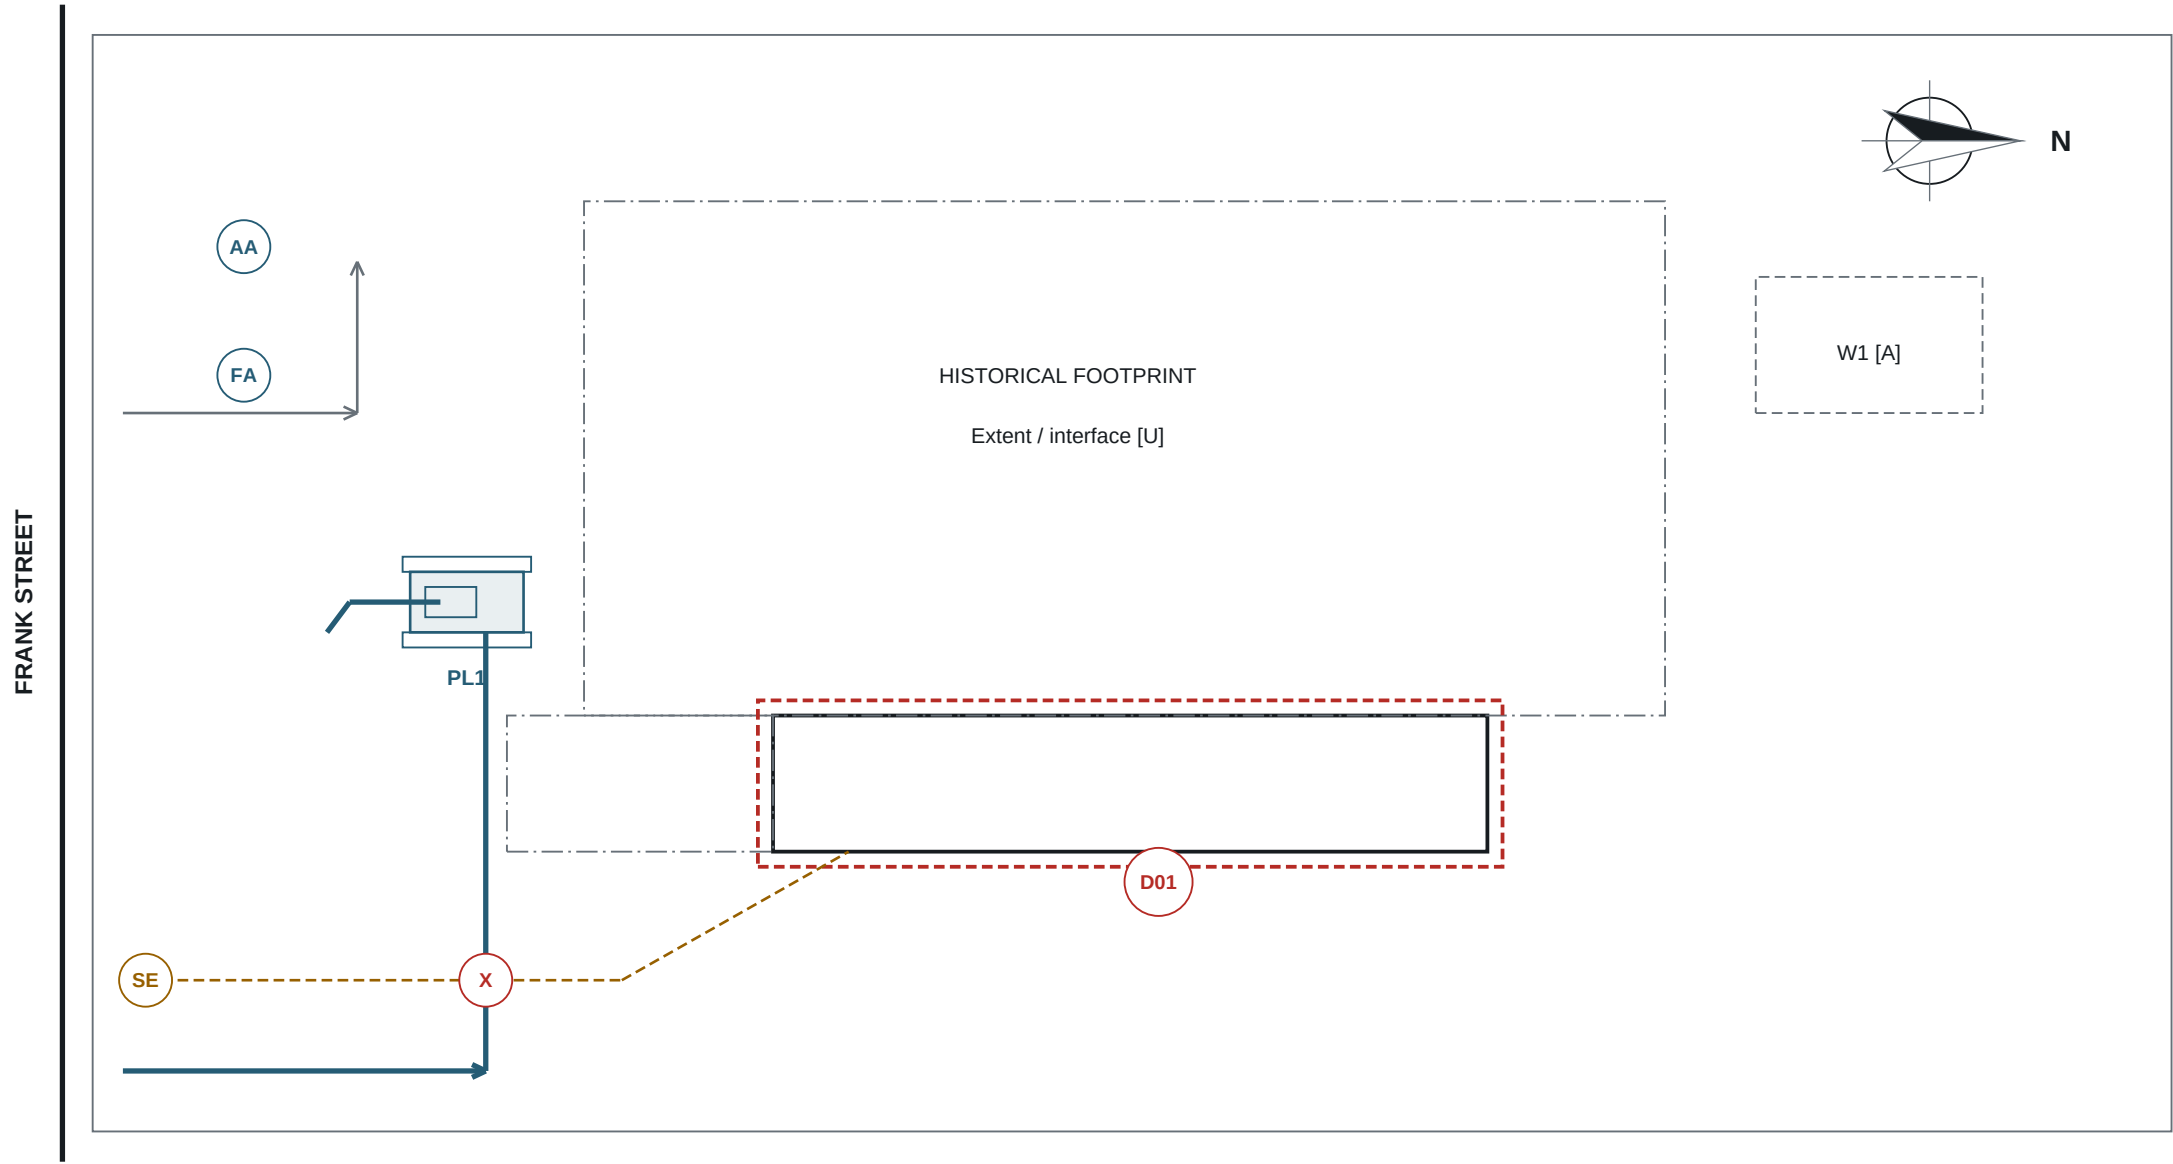
Demolition scope and site establishment

**D01** Proposed removal of selected tall shed, subject to reviewed method and approved limits.

**D02** Wall cladding appears removed in selected photos. Confirm remaining sheets and attachments.

**D03** Roof retained in observed stage. Source pulling preparation differs; see M102.

**D04** Slab / footing scope: identify proposed removal and retention in the scope response.

**D05** Review IF1/LR1 interfaces and each connecting member.

**D06** Inspect attached internal services, trays, pipework, lights and vertical runs; identify and record isolation/removal status.

PL1: non-operating plant staging. W1: proposed materials area. AA: assembly; FA: first aid. Access geometry is a coordination proposal; turning, bearing, egress and separation require checks.

X indicates a route / service investigation conflict. SE is the reported crossover entry. Also trace internal mounted services shown on V002. Record identity, supports and isolation/protection status before accepting routes or member removal.

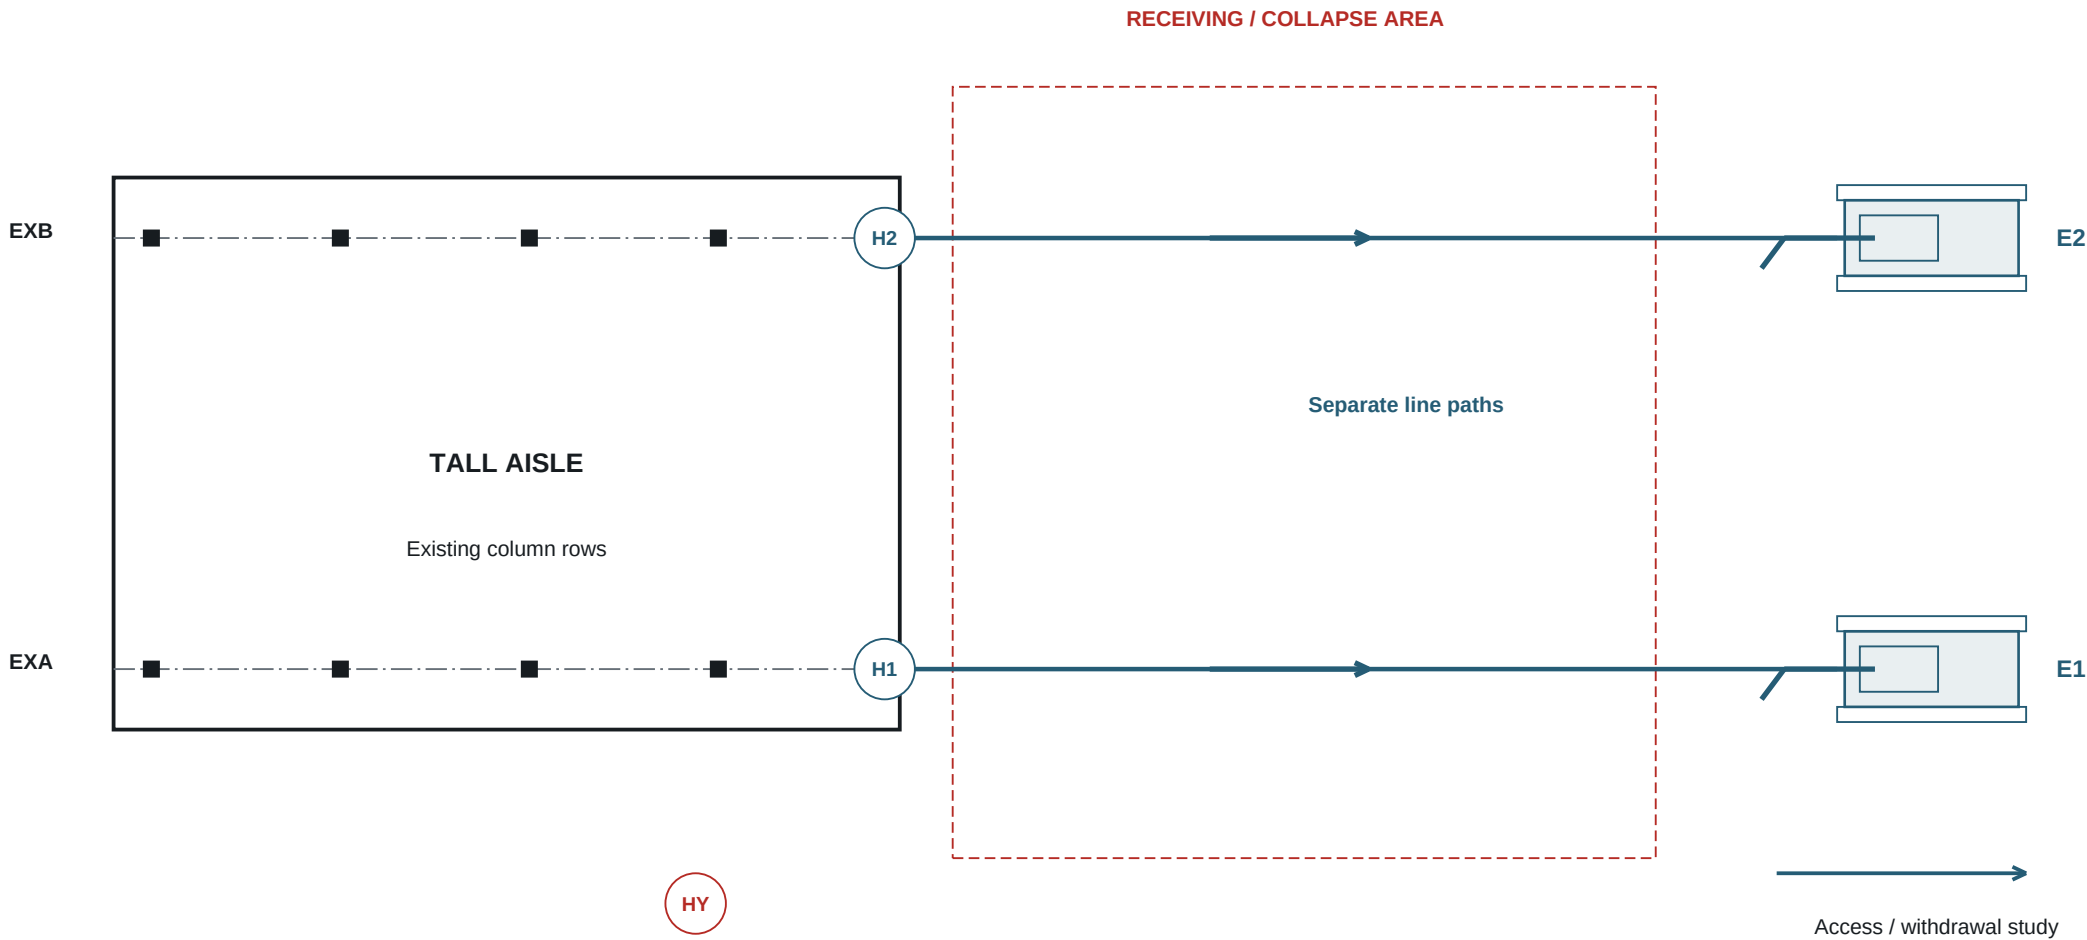
PLAN VIEW / TWO INDEPENDENT PULLING SYSTEMS

Retained hydrant interface: relative side shown for assessment. Surveyed position and protection arrangement are an RFI, not a dimensioned plant set-out.

AS 2601:2025 6.5.2.1: 1.5H = 32.4 m. NSW Demolition work Code 4.13: 2H = 43.2 m. These horizontal comparison distances are not chain lengths or complete exclusion-zone designs. Confirm the applicable requirement and actual highest affected part.

No shared central hitch. No assumption of equal line tension. Do not derive plant coordinates from this study.

Two excavators and two pull points at separate main columns. The crew intended to influence initial movement away from a hydrant. No measured force split or steering performance is established.

D10: add the actual exclusion, line-failure areas, operator protection, communications, ground checks and route constraints to the site establishment plan. Obtain coordinated plant and structural review before release.

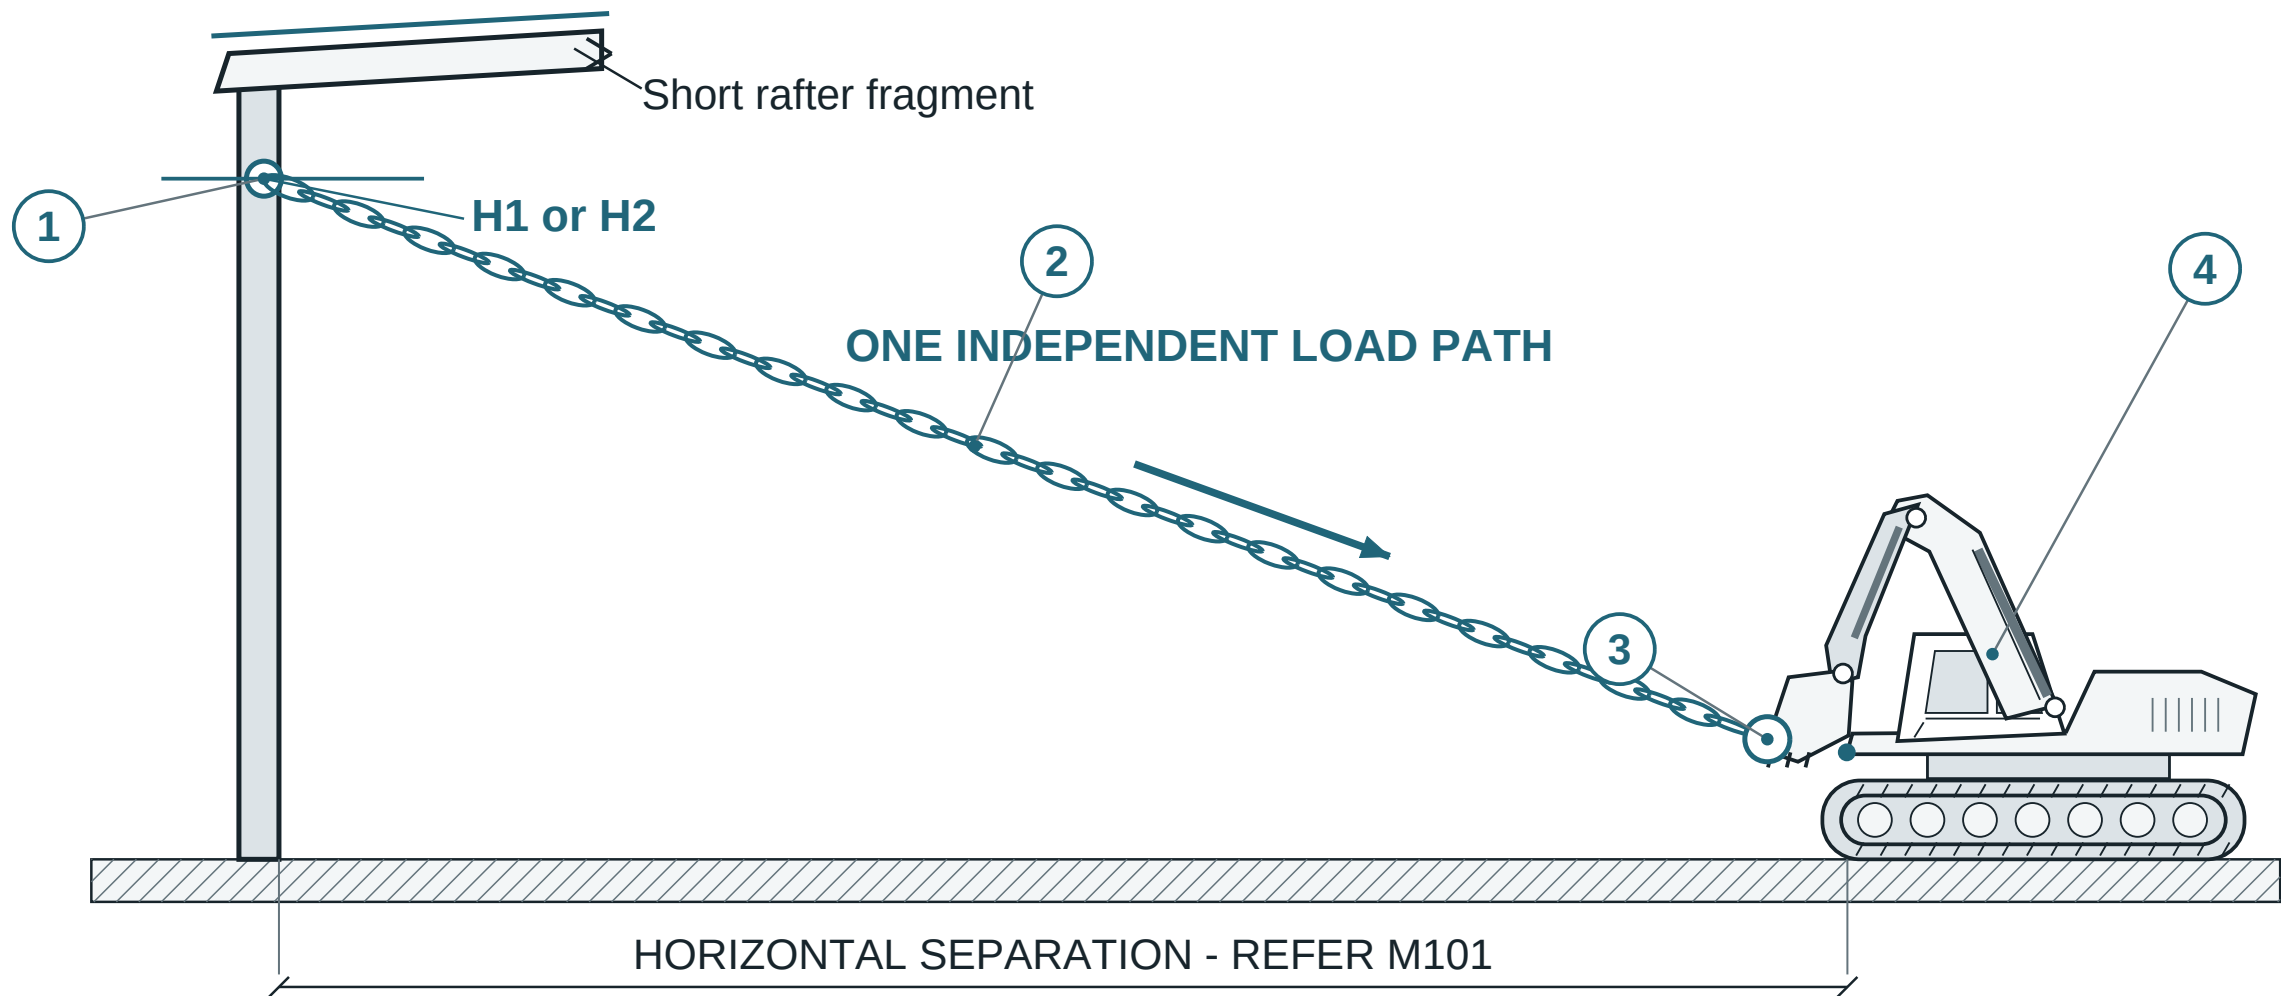
PULLING SYSTEM - COMPONENT RELATIONSHIPS

Two systems operate on separate column lines. This side study represents either system. NTS.

Hitch datum: M104. Plant point and configuration require manufacturer / engineering confirmation.  
1 Column hitch 2 Pulling line 3 Connection interface 4 E1 or E2

The column hitch transfers line tension into the frame; see M104. Both source pulling options require roof and wall sheeting removed. The roof-retained photographs show an earlier condition. Resolve stage stability in the engineering method.

The marked interface is the nominated pulling connection. Obtain manufacturer or engineering confirmation of the actual point and machine configuration; the sketch does not attach the line to bucket teeth or the boom.

Plant stability and ground reaction are part of the pulling-system design. Resolve sliding, lifting, bearing, line-failure exposure and operator protection. AS 2601:2025 6.5.2.1-6.5.2.3.
