Drawing register and general notes

27 FRANK STREET, WETHERILL PARK NSW

CEDR-27FS-DRW-003 | TEMPLATE CEDR-A3-03 v6 | 14 OCT 2026

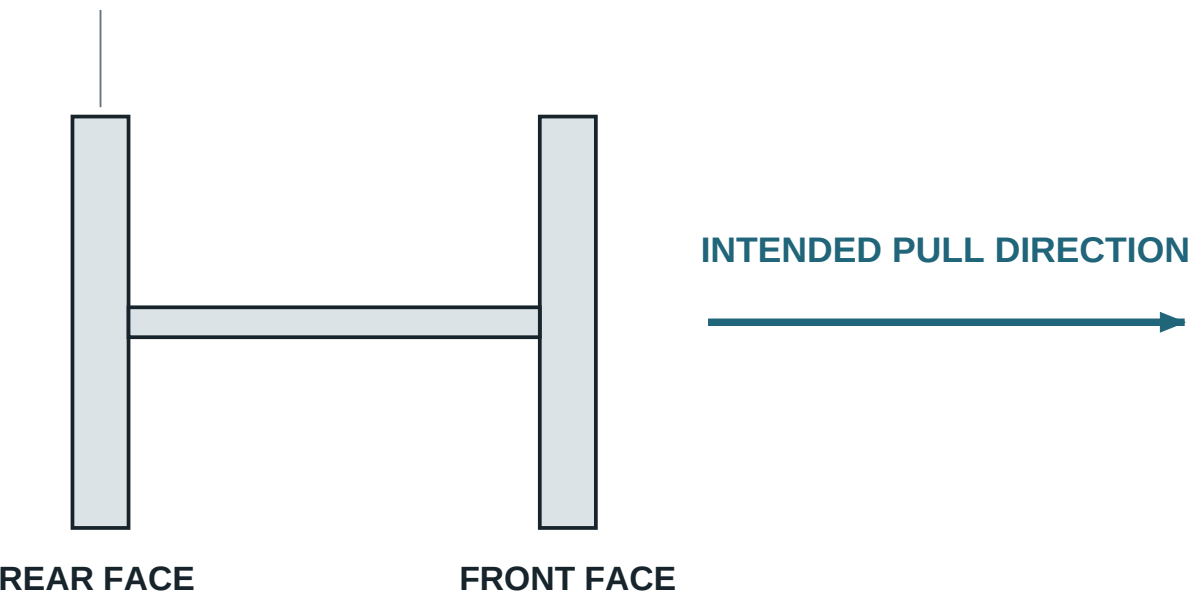
Reported rear-of-section alteration

Plan of I-section. This identifies faces; it does not specify a cut or remaining capacity.

User account: the back was broken. Original report arrows are disputed. Register the affected grid and axis.  
Engineer review must establish the actual orientation, alteration geometry, remaining section and staged stability.  
HP06 remains open until a reviewed replacement detail is supplied. Original arrows are not a cutting instruction.

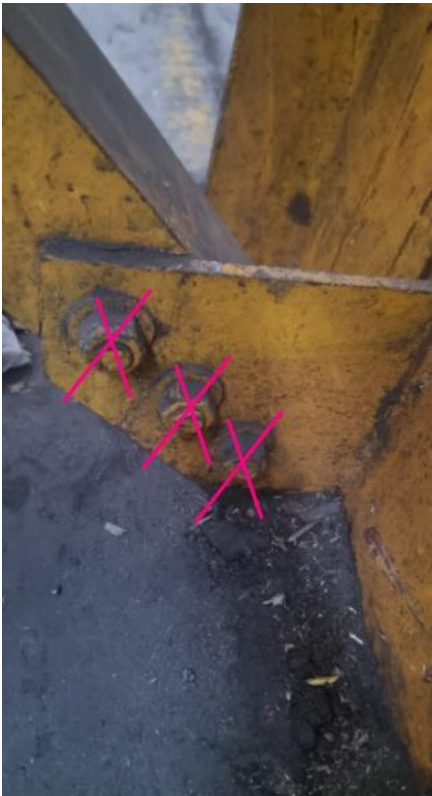
BRACE CONNECTION SOURCE

Original report p.22 Fig.7. Source marks identify a connection review location. They do not establish the current residual stability.

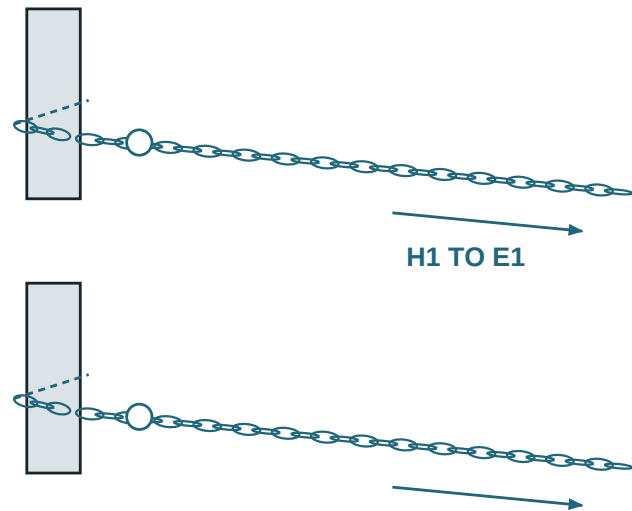
TWO COLUMNS - TWO INDEPENDENT HITCH SYSTEMS

Connection relationship study. No shared central collector and no assumed force split.

- Member orientation
- Slip restraint and edge protection
- Rated compatible connections
- Plant point and load basis
- Inspection and identification

Hitch wraps shown schematically. Select the complete arrangement for the actual section and demand.  
An equal pull intention does not establish equal line tensions or a reliable steering response.

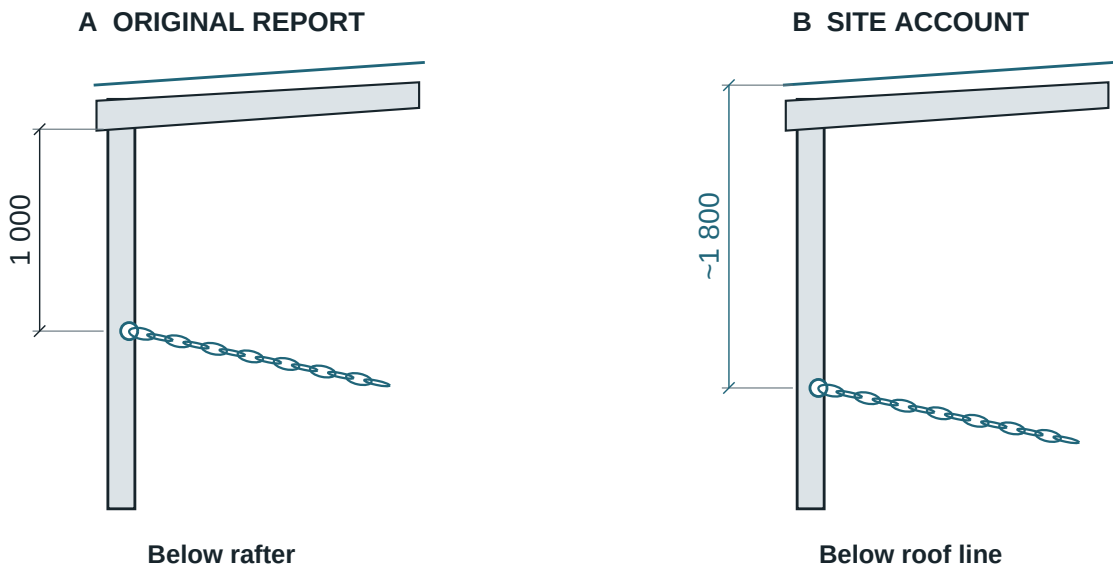
HITCH HEIGHT - DATUM COMPARISON

These are separate accounts with different reference surfaces; neither is an AS 2601 prescribed hitch height.  
Confirm the roof-to-rafter geometry, location of the loaded chain and connection design. NTS.

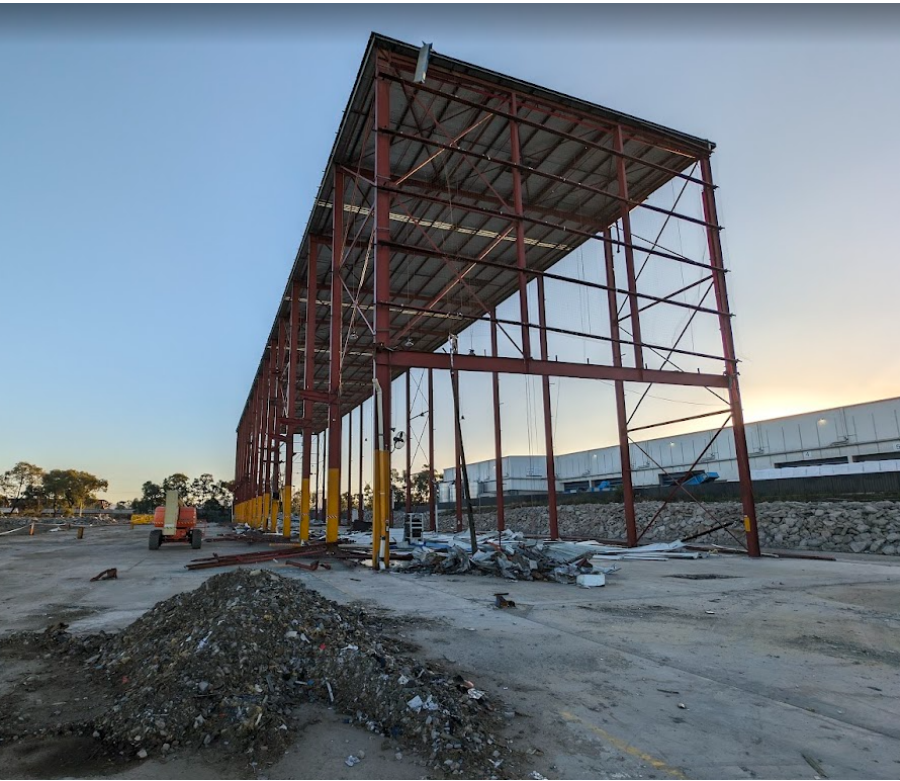
P04 - STRIPPED WALLS / RETAINED ROOF

Red/brown main steel; slender girts and bracing; deep horizontal members below roof level; end subdivisions; roof sheeting, netting and lights. Photos do not establish member capacities, connections or dimensions.

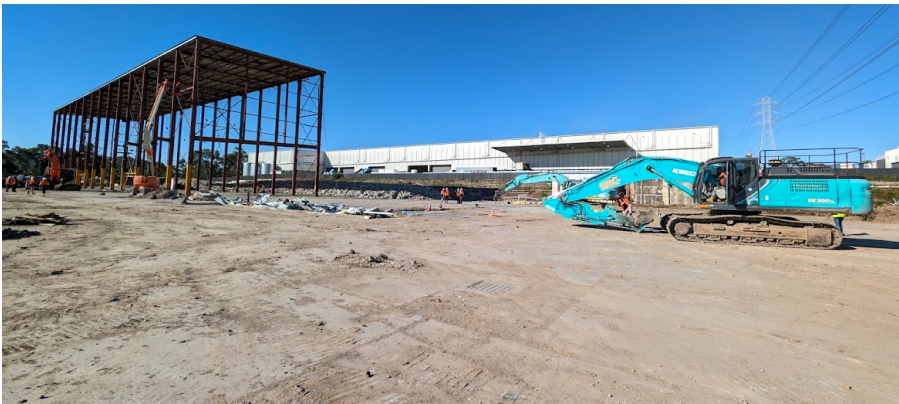
P08 - YARD / DRAINAGE CONTEXT

P08 shows a grated inlet and distant overhead line infrastructure. Drain identity, levels, outfall, line voltage and clearances remain unverified. Machine appearance does not establish an approved pulling configuration.

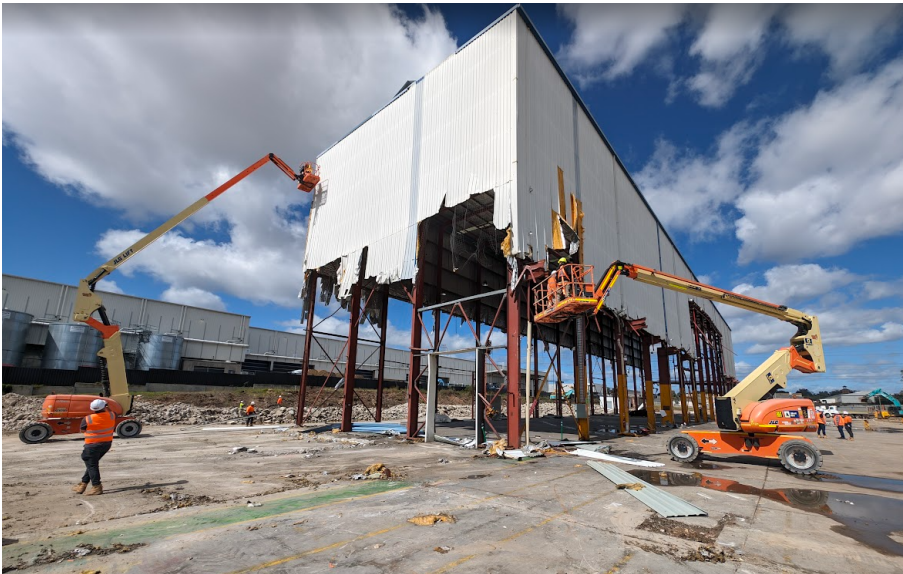
P09 - PARTLY CLAD CONDITION

First inspection is recorded on V002. P01-P04/P08 show largely stripped walls; P05-P07/P09 retain substantial upper wall cladding. Capture chronology is unverified. Both source pulling options require roof-sheet removal; refer M102.

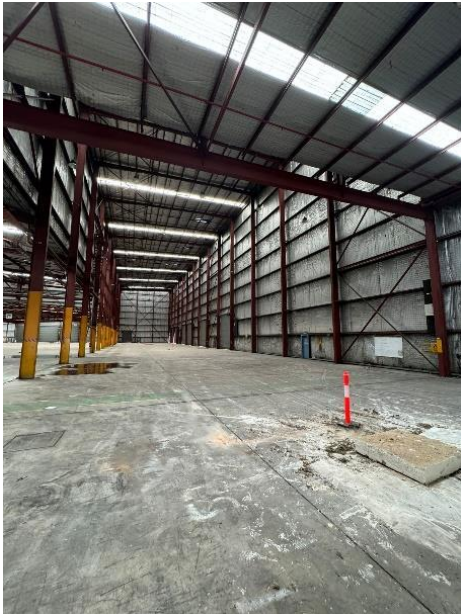
**I10-04**  
Source p.10 middle-right

Full-height enclosure, horizontal girts, rooflights and bracing before strip-out.

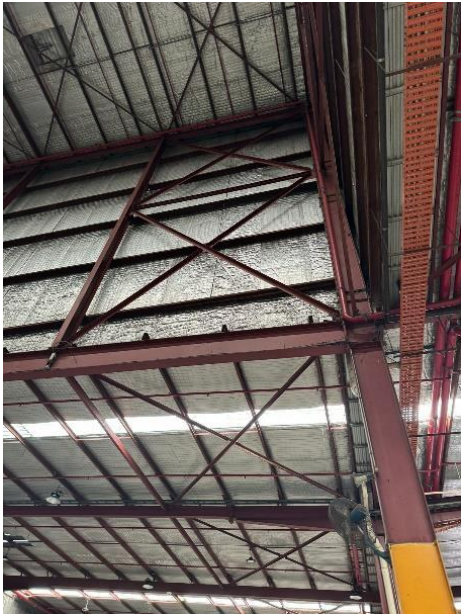
**I12-04**  
Source p.12 middle-right

Stacked upper braces, IF1 junction, adjoining lower roof and attached service runs.

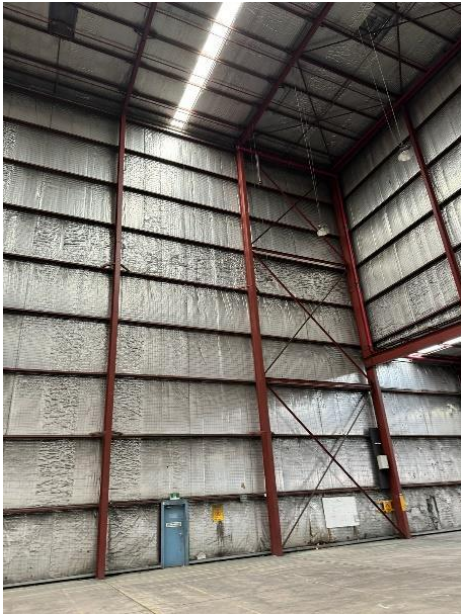
**I13-03**  
Source p.13 middle-left

Multiple diagonal panels with intermediate horizontal members; low solid wall zone.

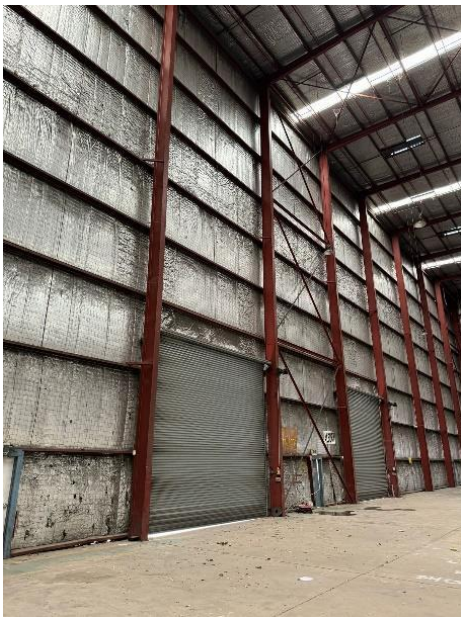
**I14-01**  
Source p.14 top-left

Roller shutters and personnel door interrupt the wall; header, jamb and brace relationships.

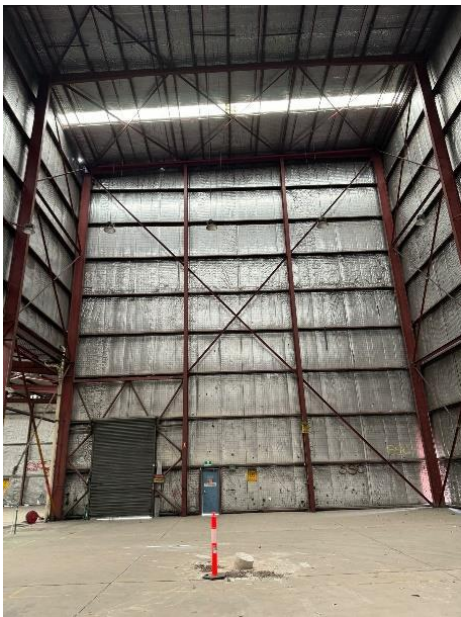
**I14-06**  
Source p.14 bottom-right

End posts, diagonal arrangement, girts, door and rooflight strip; correlate end orientation.

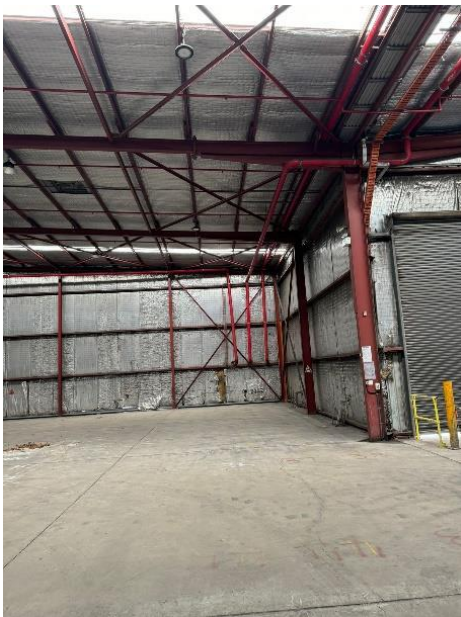
**I11-06**  
Source p.11 bottom-right

Overhead/vertical runs, fittings and wall opening. Contents and status require records.
